Inspection Report Minerals Regulatory Program

Report Date: November 29, 2004

Mine Name: Goldstrike
Operator or Permittee Name:
USMX
Permittee Mailing Address:
None

Permit number: M/053/005
Inspection Date: November 16, 2004

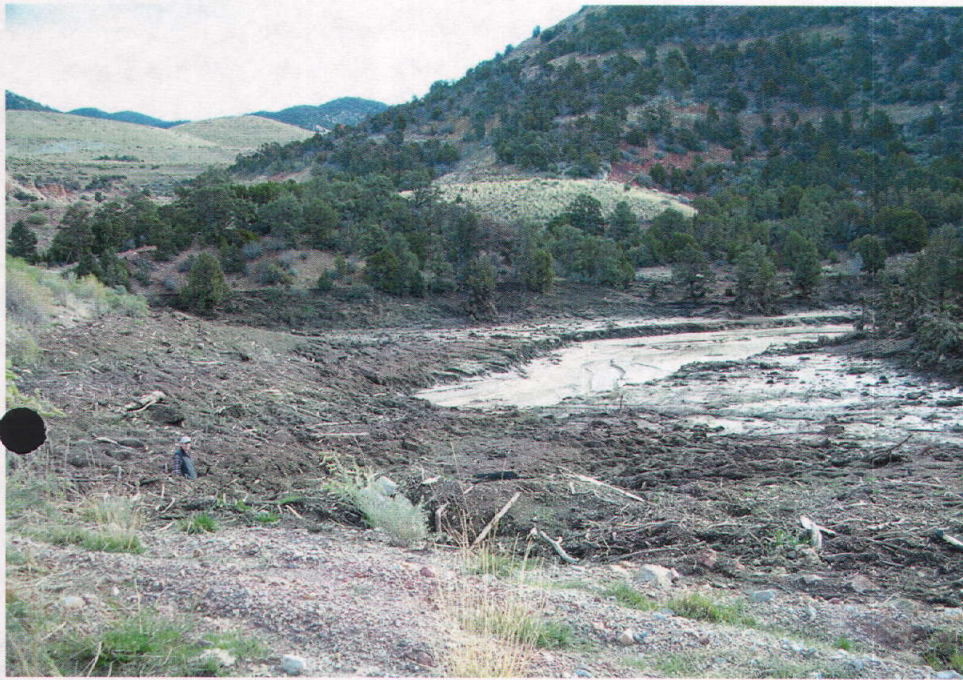
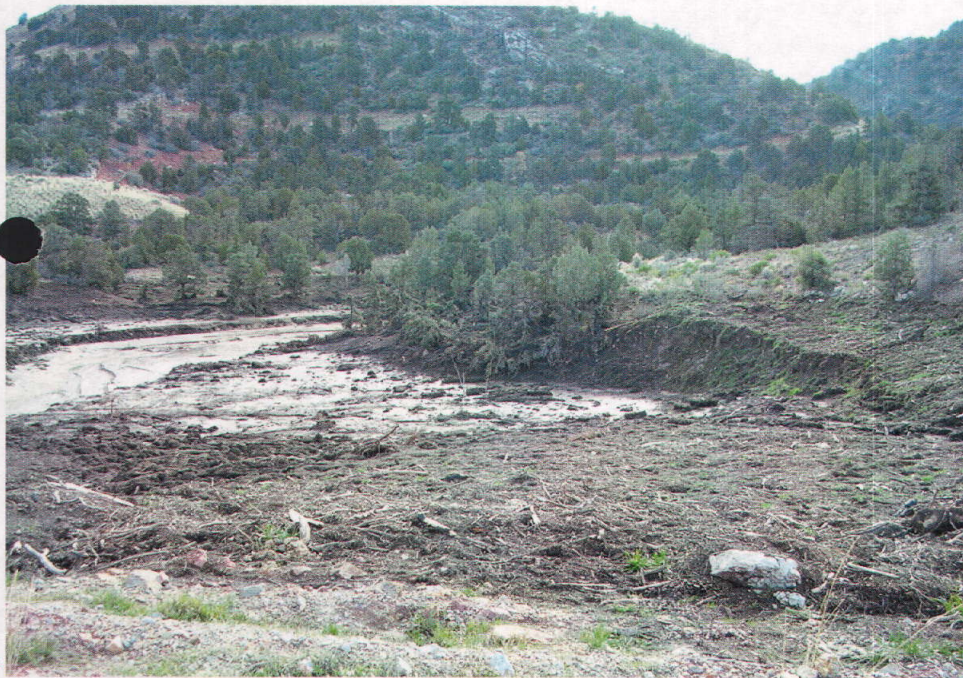
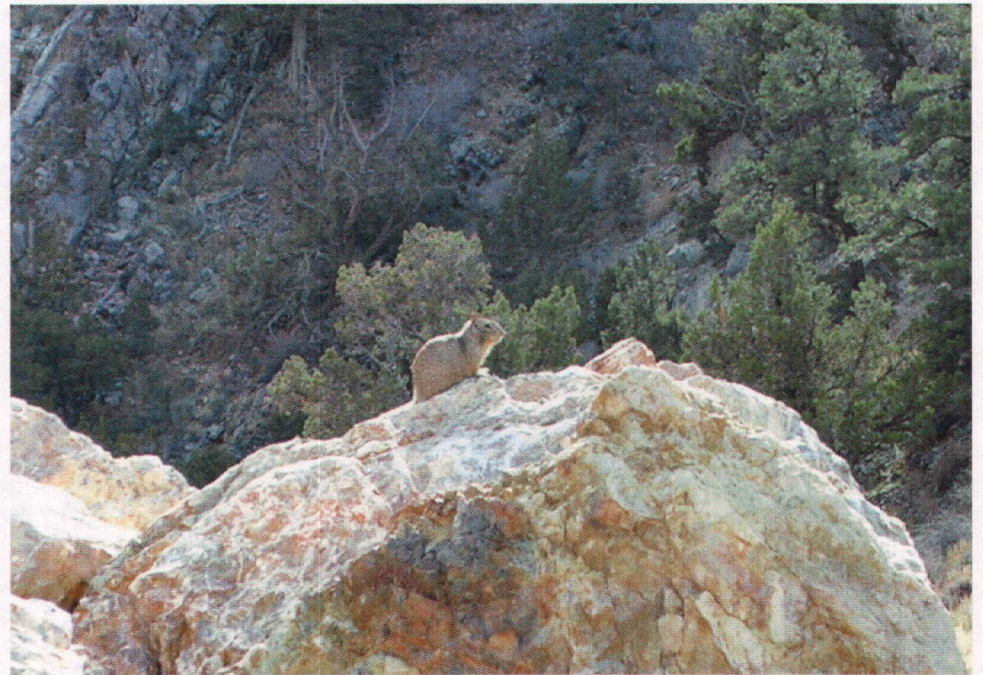
Dan Slyter, state contractor, had discovered that a recent storm in the area had blocked the culverts under the mine access road at Arsenic Canyon. There is both an 84" and 48" culvert that have been placed in this area. They were both blocked due to debris from a fire last summer that burned off the vegetation above the mine. A heavy downpour on this burned area resulted in a large amount of material being washed down the canyon which blocked both culverts. Dan was concerned that another downpour could result in the loss of the mine access road if the blockage was not cleared.

When we arrived on site we found that another storm had hit since Dan's inspection and the 84" culvert had cleared itself. Much of the material, which had backed up above the road, had washed through the culvert and the drainage now looked pretty good. Some effort will still be required to clear the 48" culvert but with the clearing of the larger culvert, the potential loss of the road in this area is no longer a concern. Dan will clear the debris from the smaller culvert as time allows. Photos of this area were taken and are included in this memo.
